Pollution in the Creek

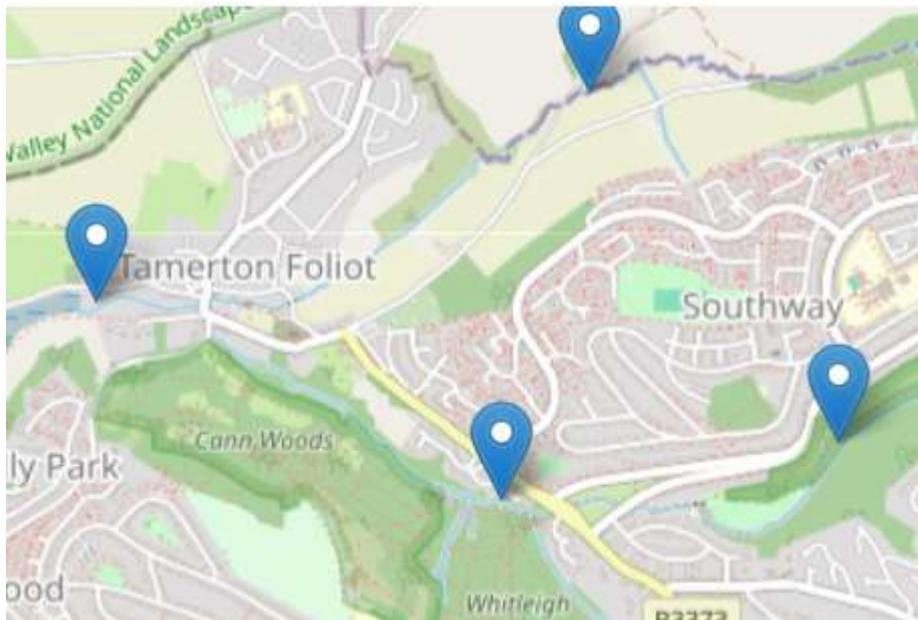
The main sewer lines broadly follow the same route, combining to form the trunk sewer that carries flows to Ennesettle Treatment Works. Along this network there are four licensed Combined Sewer Overflows (CSOs).

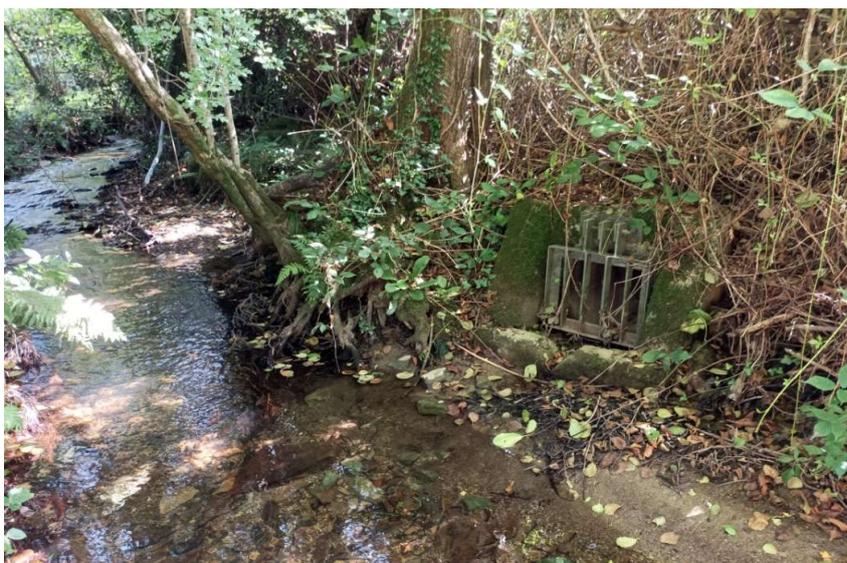
One such outlet is located near Haysend Farm.

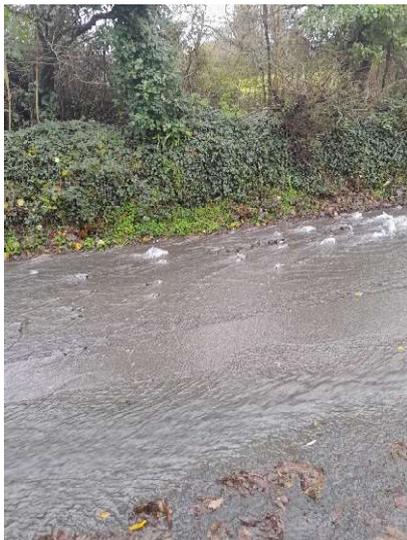
As a result, the manhole in Church Row Lane regularly overflows, discharging foul water, including faecal matter and sanitary products, onto the road and directly into the stream. A recent incident occurred on 9 December 2025.

South West Water installed an electric sluice gate to regulate flows within the system, but this has not resolved the problem.
